Camp 22 Pennylands

Dumfries House, Cumnock, East Ayrshire

Community Excavation: March 2017

Report Date: August 2017

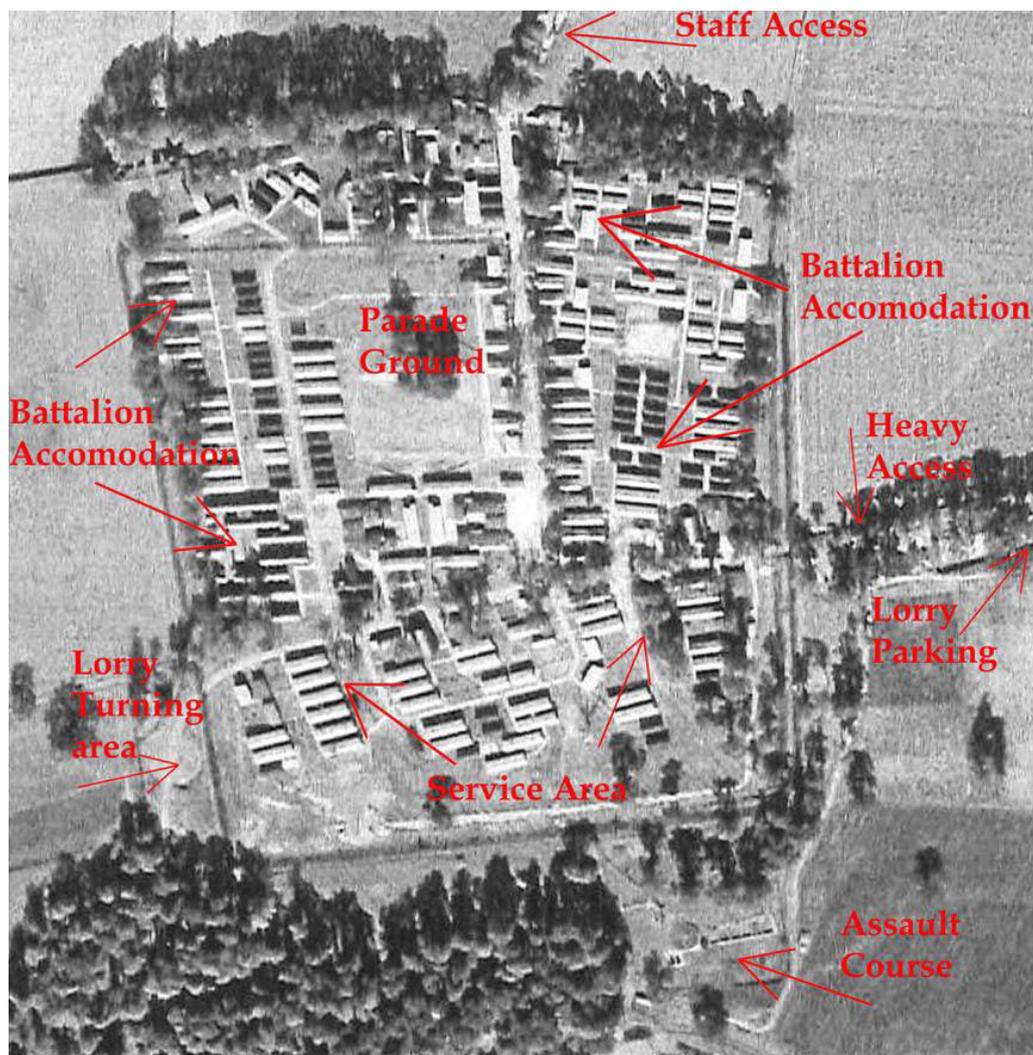
Figure 2 Aerial photograph of camp taken in 1945, annotated by NMRS (north to top).

The Military Camp was located adjacent to The Temple during World War II and is recorded on aerial photographs taken by the RAF in 1945 (*figure 2*). The photographs reveal over 100 huts within the compound, several of which have 'formal gardens' to the rear. In the central area of the camp is a group of larger huts, presumably the mess, kitchen and recreation buildings. The military camp was built in 1941 and latterly became a Prisoner of War Camp in 1943. After the war it was used for allied troops awaiting repatriation and from the late 1940s/early 1950s as social housing.

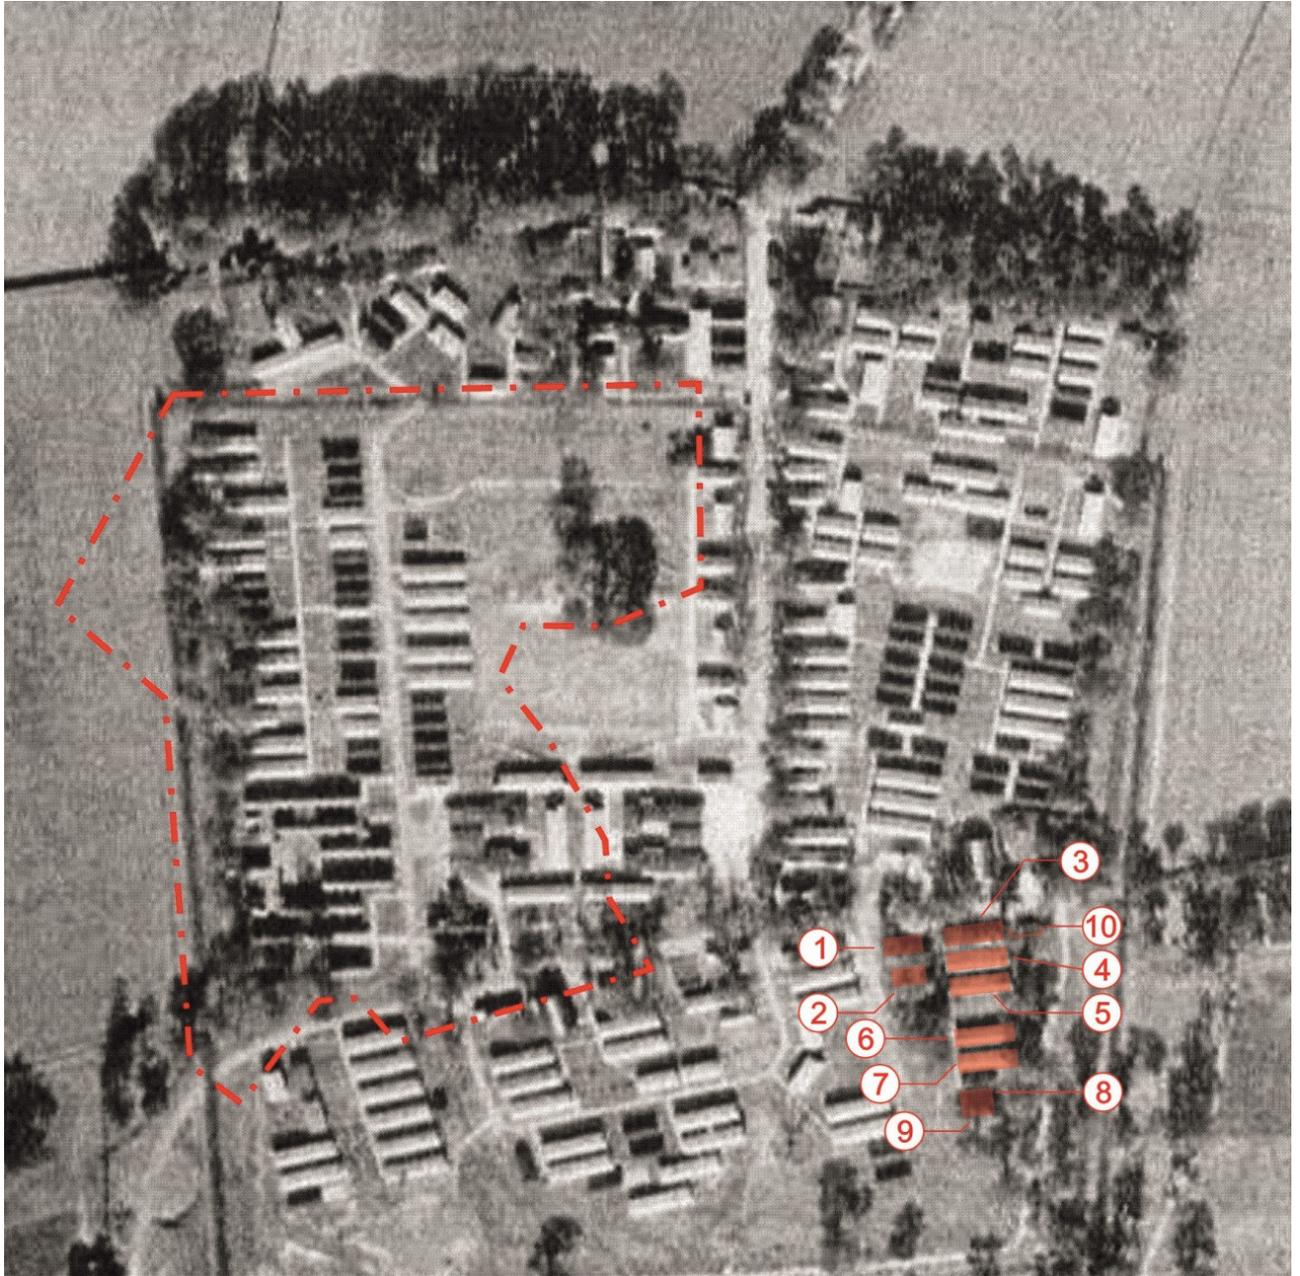
Figure 3 Aerial photograph of camp showing buildings identified in bottom right hand corner. The area of the previous excavations is outlined in red (north to top).

Nine huts were surveyed in the woodland area under investigation. The layout has been superimposed on the aerial photograph of the site, showing those huts which were identified (*figure 4*). Of the two huts in the western row, the first (Hut 1) was cleared of vegetation and recorded (see below). The evidence suggests that this was a shower/washing block, with rows of basins set out. The adjacent hut (Hut 2) is thought to have been a toilet block, by association.

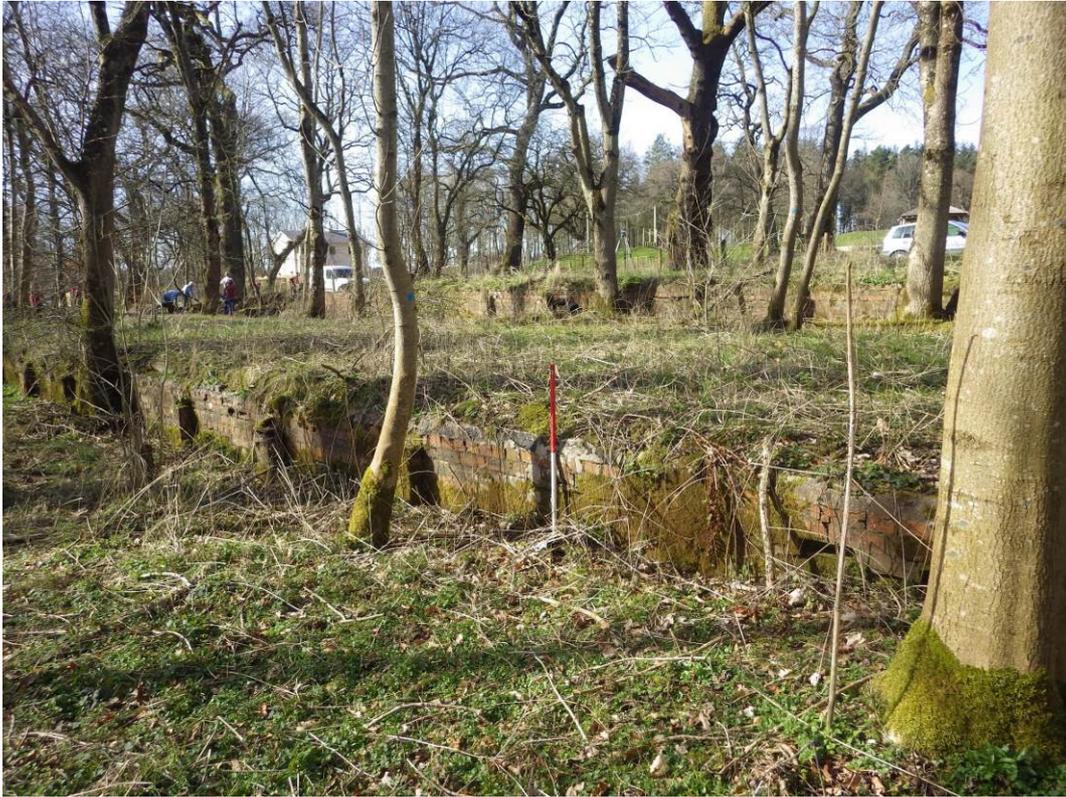
Plate 2 Hut 4, with Hut 3 in the Background, looking north-west

On the eastern row, the first 5 huts (Huts 3 – 7) are of similar dimensions and are thought to have been accommodation blocks (*plates 2 and 3*). These were of similar size to those uncovered during the excavation in 2016 (Scott Coulter pers comm). The larger gap between huts 5 and 6 is likely to be due to topography. The accommodation blocks measured 21m by 6m. All the huts had been built

into the slope so that the northern elevations only survived as high as the concrete floor, with the southern elevations between 0.63 - 1.05m in height, with around 7-8 courses of bricks on average; Hut 5 survived to the greatest height of 1.05m with 12 courses exposed (for more detail on each hut, see *Appendix 1*).

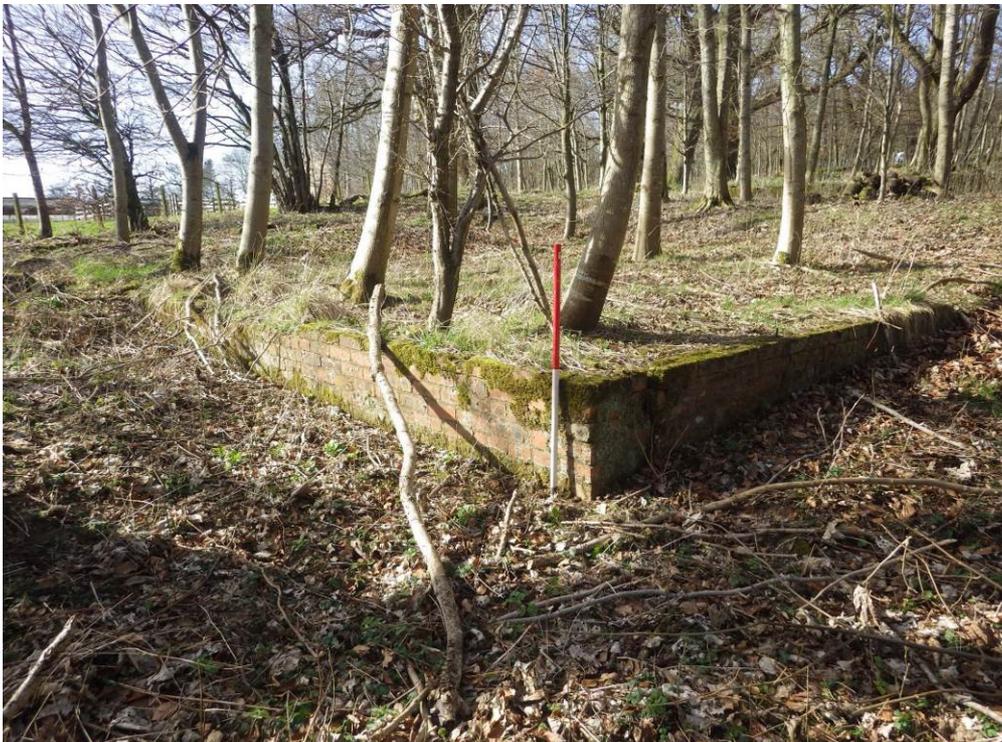
Plate 4 Hut 9 looking north-west

Further down the slope were two additional huts (Huts 8 and 9; *plates 4 and 5*). Their smaller size suggests they were used for something different and it is suggested that they may have been stores or workshops. Hut 8 was very overgrown and only identified by its corners protruding through the grass (*plate 5*). It measured 11m by 3m and was 0.24m in height on the southern side, with three brick courses visible at the highest point in the south-west corner. It was only one metre north from Hut 9, which measured 11m by 5m and was 0.5m high with six courses and was far clearer (*plate 4*). A further hut (Hut 10) was identified 3m to the east of Hut 3 (*plate 6*). The north side of Hut 10 was not

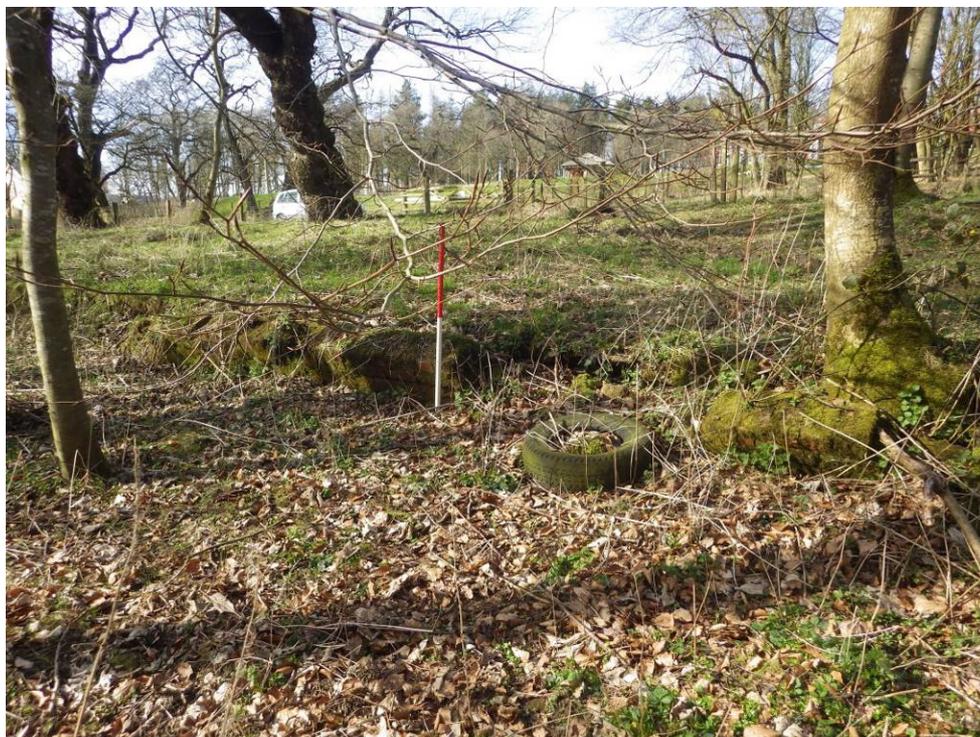
Plate 6 Partly buried south wall of Hut 10, looking north-west

found, but the southern side ran on the same line as the southern side of Hut 3 and was 11m in length. The southern side was 0.87m in height and 10 courses high and the wall had partially collapsed; the hut was partially buried and the sides were also not clearly visible. The dimensions are similar to Hut 9 so it is likely to have had the same purpose, perhaps as a workshop associated with the blocks at the top of the slope.

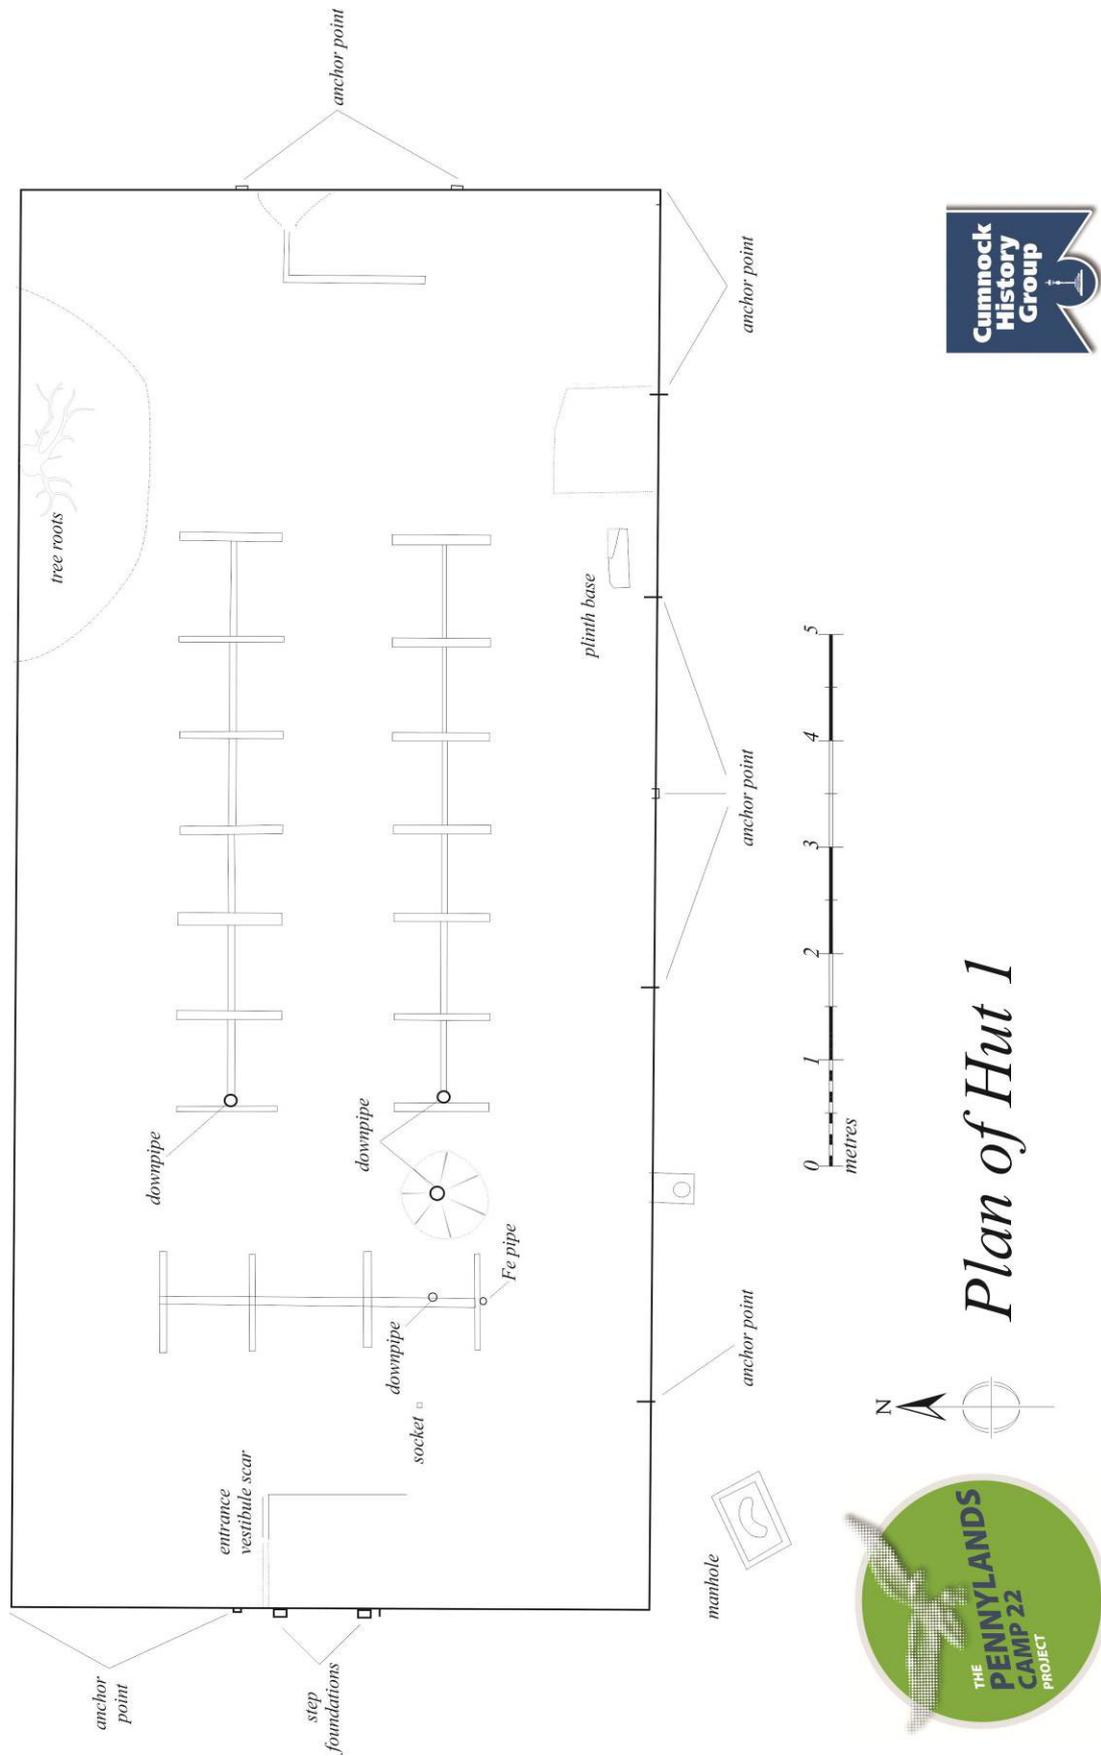
Figure 4 Plan of Hut 1

Hut 1 measured 13.30m by 5.75m and stood 0.60m high (*figure 4*). It was built of a brick base, of which six courses were visible, with an upper concrete floor 0.12m thick [2003]. There was evidence for the stands for 30 wash basins as well as a series of drains and pipes on the southern side (*plate 8*). A small area in the north-eastern part of the building had been obscured by tree roots.

The concrete screed floor had been poured after the construction of the brick basins as the concrete abutted the brickwork. The screed was recessed 0.07m from the exterior wall face, indicating the thickness of the walls. At each end of the building was an L-shaped recess in the concrete, indicating the location of the entrance vestibule (*plate 7*). There were also a series of anchor points located around the building. These were of concrete and measured 0.25m square, some of which had surviving iron brackets still attached. These were for fastening the superstructure to the base of the building.

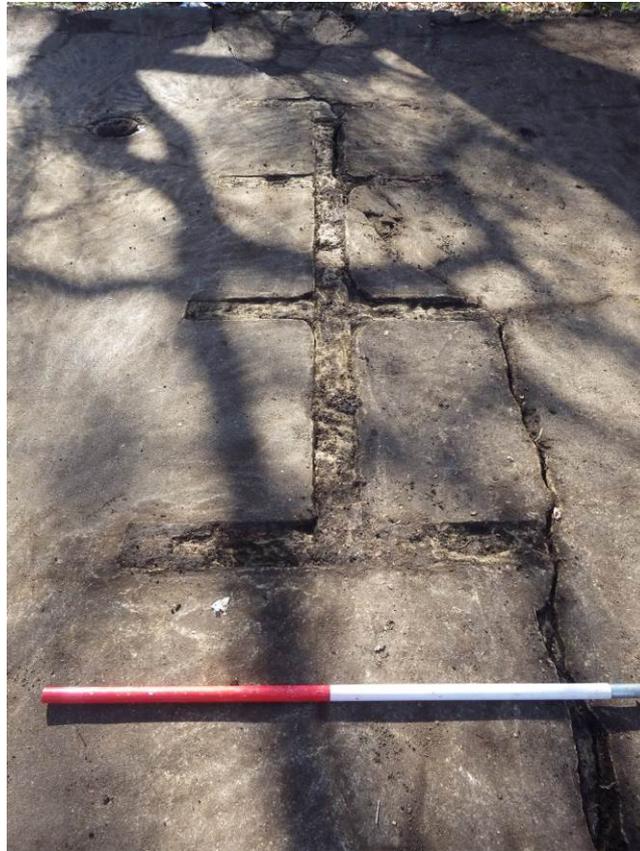
Plate 8 Hut 1, Detail of Westernmost Basin, Brickwork and Drain, looking south

Within the floor were three sets of brick-built basin supports, two aligned east to west [2006, 2007] and one at the west end aligned north to south [2008]. The brickwork for the supports was one brick wide. The location of four downpipes were also identified – one associated with each of the banks of basins and one with a drainage point in the floor [2005]. This separate drain was surrounded by a circular dip in the floor approximately 1.50m in diameter (*plate 8*). The associated pipework would have been above floor level.

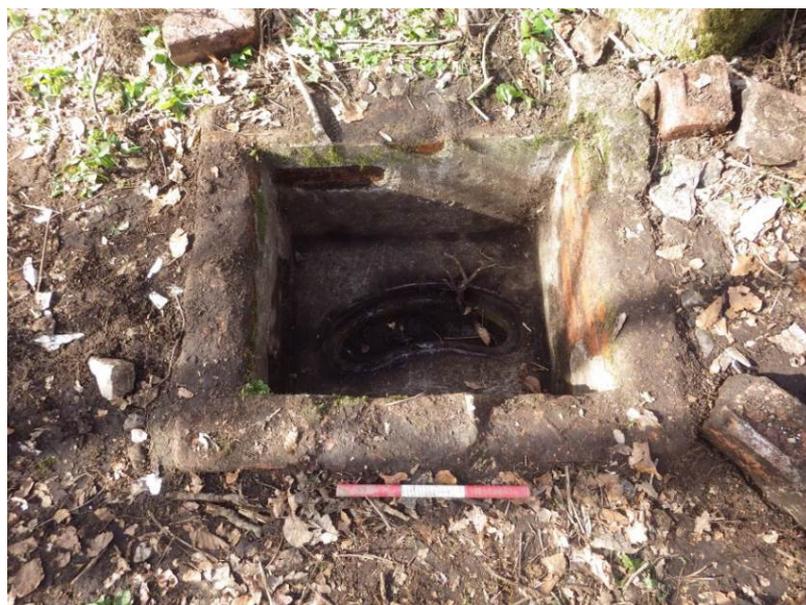
Plate 9 Hut 1, Brick Drain [2002] looking north

There were a number of associated drains on the southern side of the building. Near the south-west corner was a rectangular brick-built drain with internal dimensions of 0.60 x 0.50m and 0.40m deep [2002]. The interior was rendered and there was a kidney-shaped silt trap in the base (*plate 9*). The drain was filled with a mixture of silt and rubble [2001], containing a number of fragments of white ceramic sanitary wares stamped 'Adamsez Ltd Scotswood on Tyne' (*plate 10*). Adamsez was originally established in York as *Adams and Co* making automatic cisterns and tanks. In 1902 Adams and Co took over *W. C. Gibson and Co* of Scotswood and moved the sanitary ware arm of the business to Scotswood, near Newcastle-upon-Tyne; the Gibson takeover included the Scotswood Fireclay Works and collieries which led Adamsez to diversify into firebrick manufacture (<http://www.gracesguide.co.uk/Adamsez>). The need of the camp for both firebricks and sinks may have made them a useful supplier.

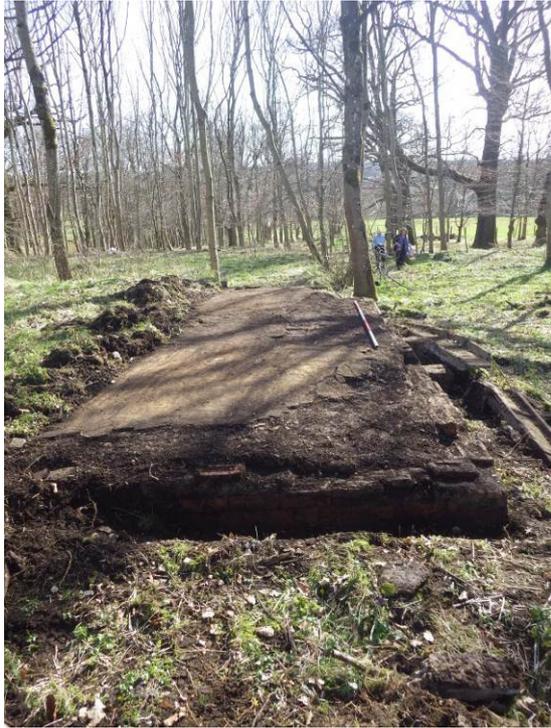
Plate 11 Hut 3, looking south

The accommodation block was only partially excavated, primarily to expose the western elevation and a curious concrete structure that was up against it (*plate 11*). The western wall of the building survived up to 0.46m in height, with 4-5 courses exposed. In the centre of the side elevation were parallel brick piers, which would have supported concrete or wooden steps to the entrance, as seen on a number of the previously excavated huts. The concrete structure was approximately the width of the building (6m), although it did not appear to be *in situ*. It was formed of a single piece of cast concrete, tapering at both ends from a width of 0.3m in the centre. The uppermost side was recessed to form a shallow rectangular basin, separated by a series of concrete 'bars' across the basin. This appeared to relate to drainage or run off and may have been formerly located at the side of the building to drain the water away downslope.

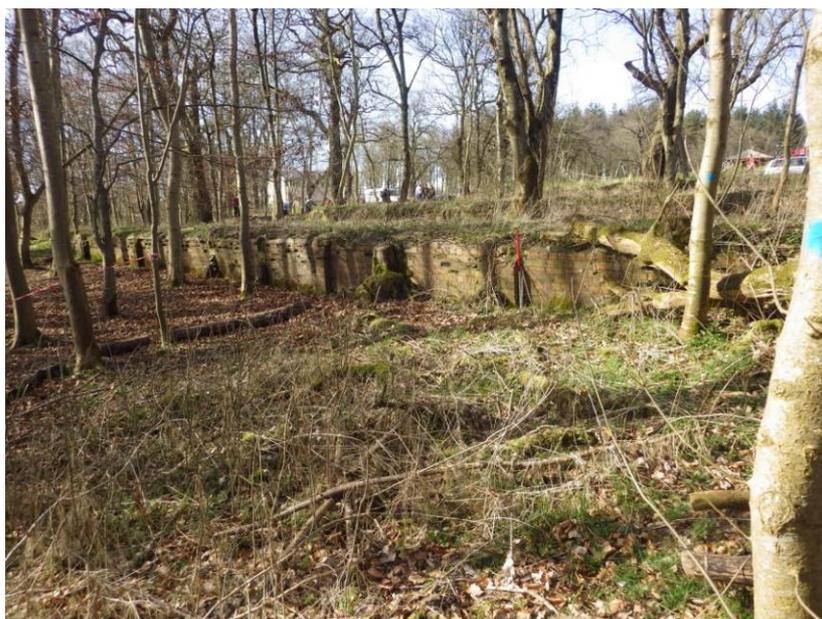
Plate 13 Hut 5, south elevation, looking north-west

An elevation drawing was made of the southern elevation of Hut 5; the elevation was identical to those of Huts 3 and 4 but was most clearly exposed at Hut 5. The elevation exposed walls of at least 0.8m in height and was 21m in length. A series of brick piers were visible at approximately 2m intervals along the length of the elevation; these were a single brick wide (0.2m) and six bricks high, which had been laid on their sides (*plate 13*).
